2019 Evaluate Two Watershed Plans APDES Permit No. AKS-052558

**MUNICIPALITY OF ANCHORAGE
WATERSHED MANAGEMENT PROGRAM**

December 20, 2019

Prepared for: Municipality of Anchorage
Watershed Management Services

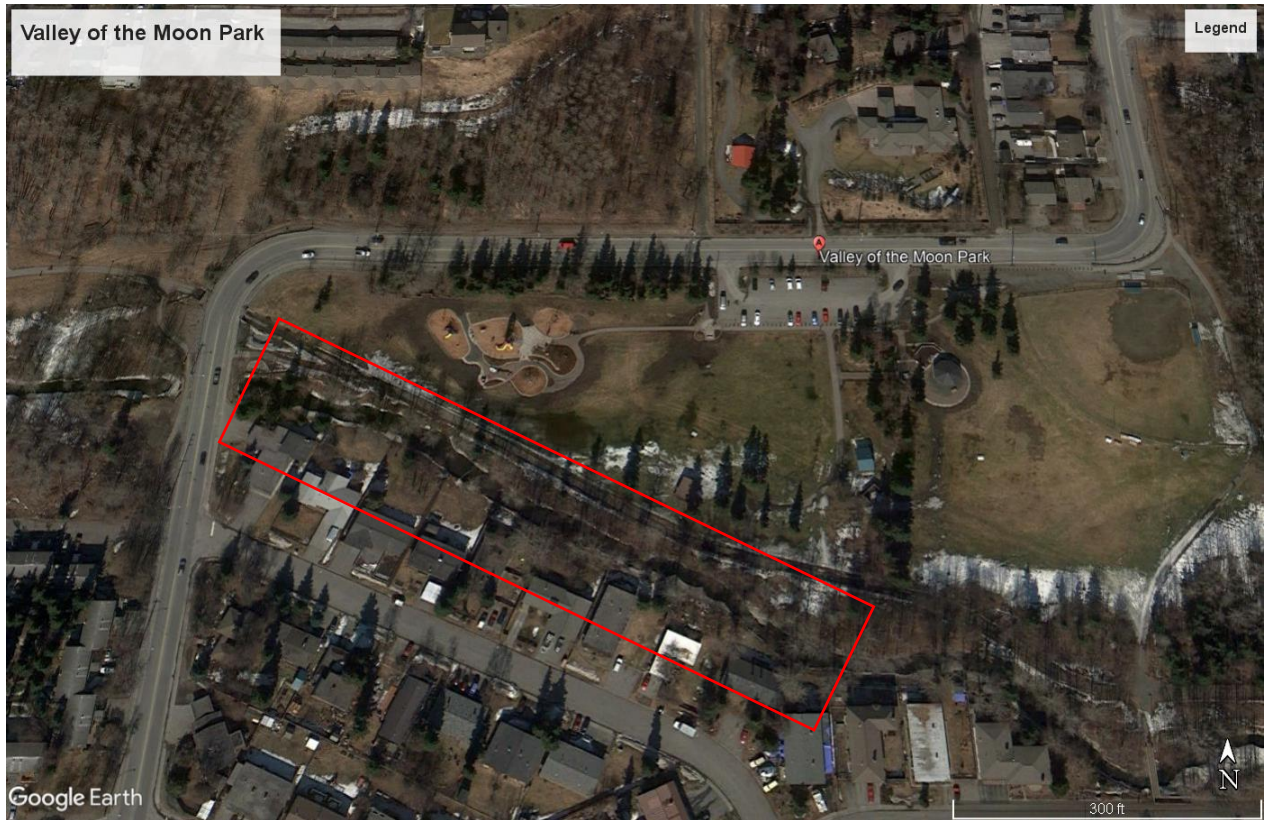
Fig. 1 Approximate area of bank trampling (CW-4) and properties needing vegetation buffer (CW-5)

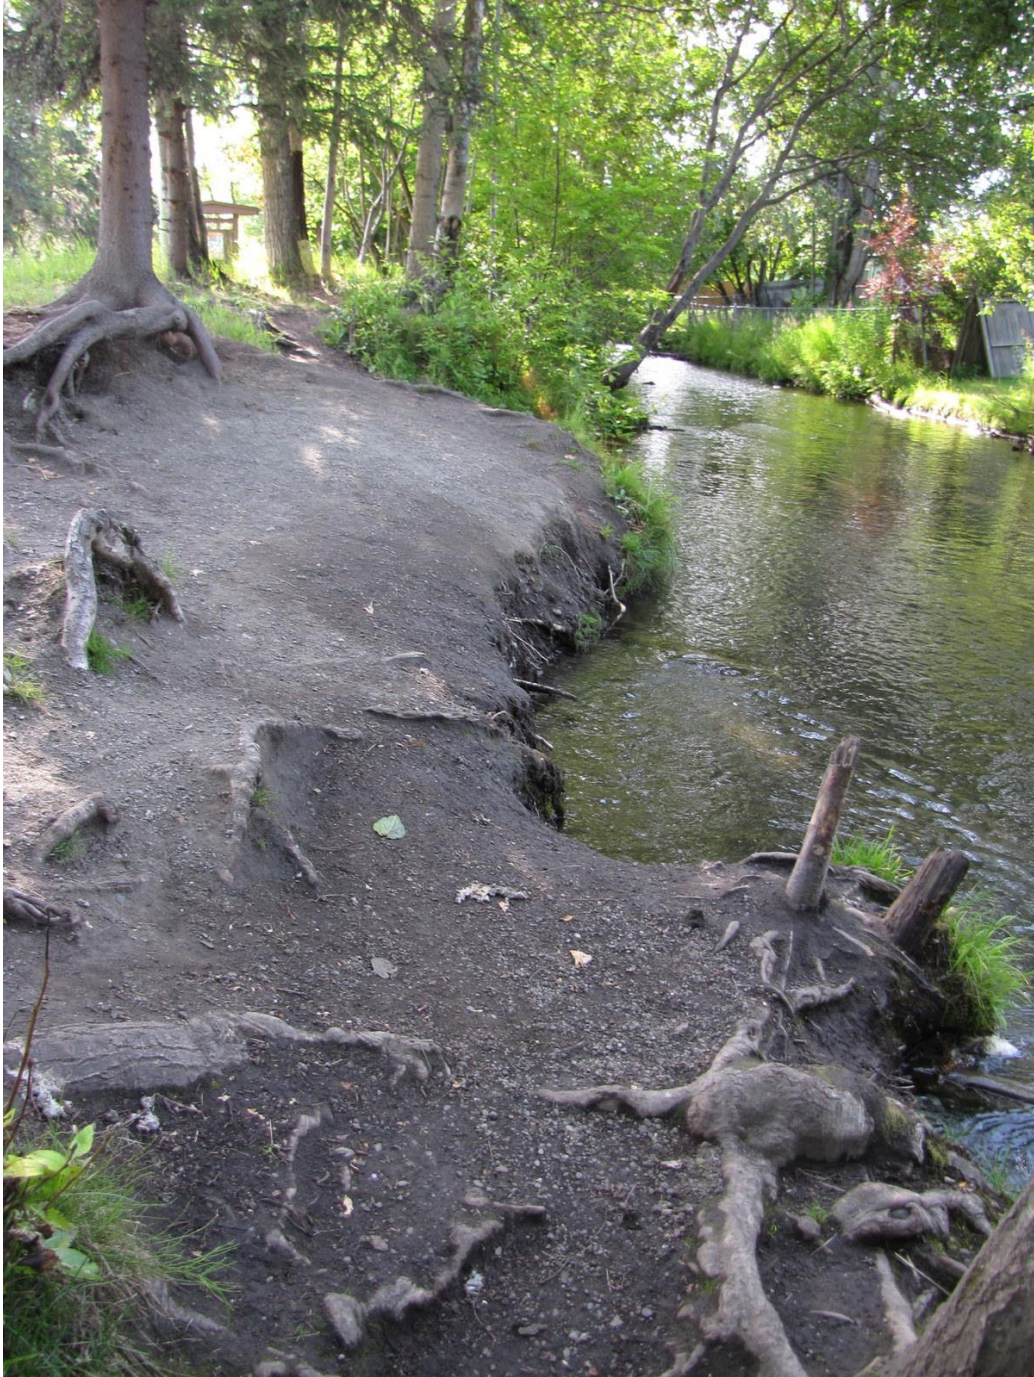
CW-4, “Streambank trampling along Chester Creek at Valley of the Moon after revegetation and access stairs being replaced in 2013”. AWC reviewed the area on 10/3/17 and reported that the stairs need repair and people are still using and trampling long stretches of the bank on the west (park) side. Photos follow.

Fig. 3 West bank of Chester Creek showing eroded bank in 2011 (CW-4)

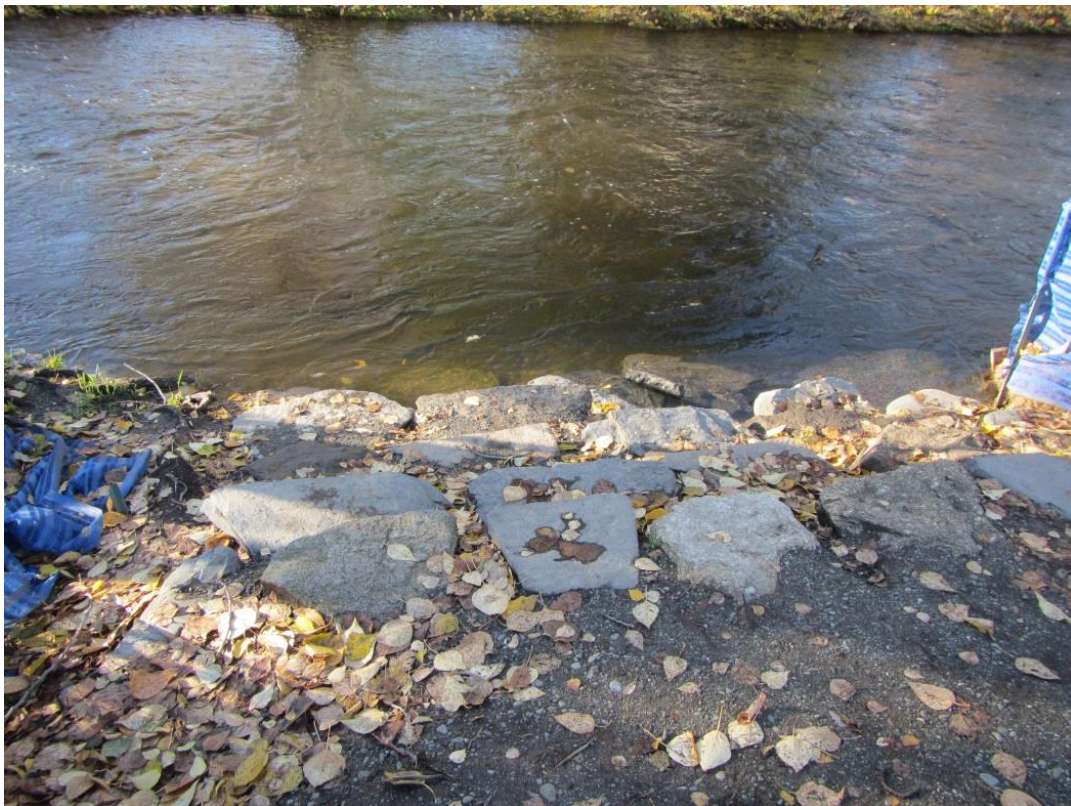
Fig. 7 Close-up of stone steps at Chester Creek along west bank in 2013 (CW-4)

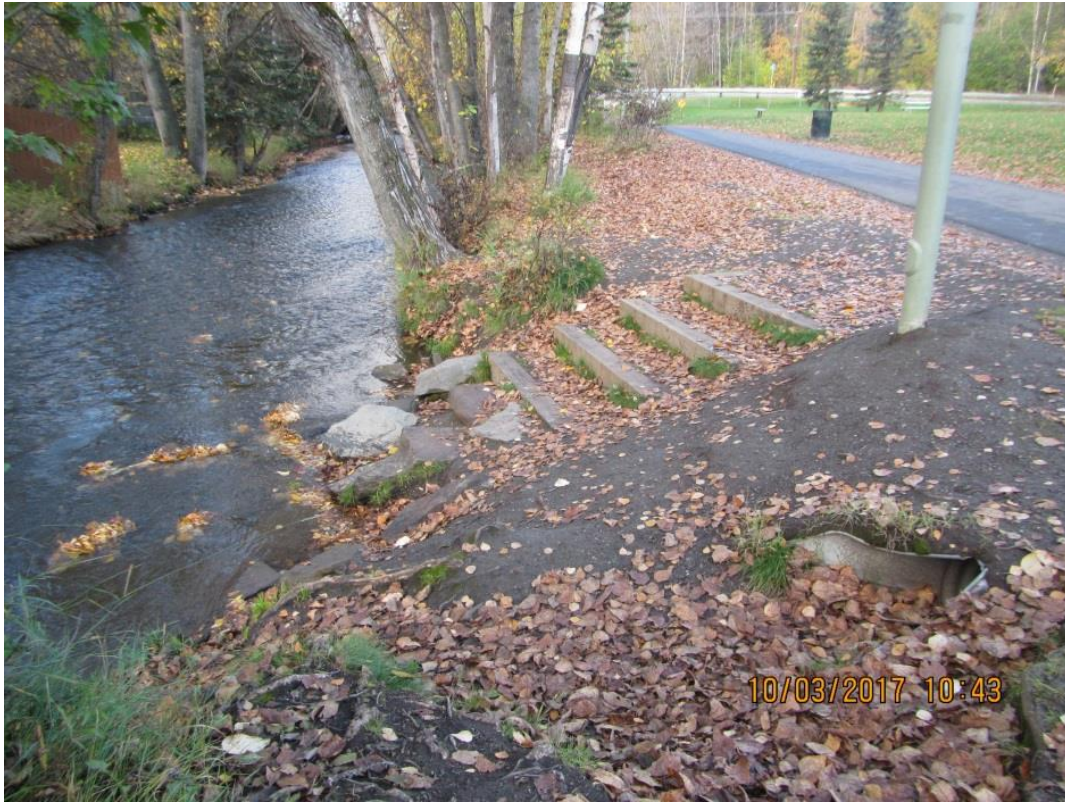
Fig. 8 Area near stone steps at Chester Creek along west bank in October 2017 (CW-4)

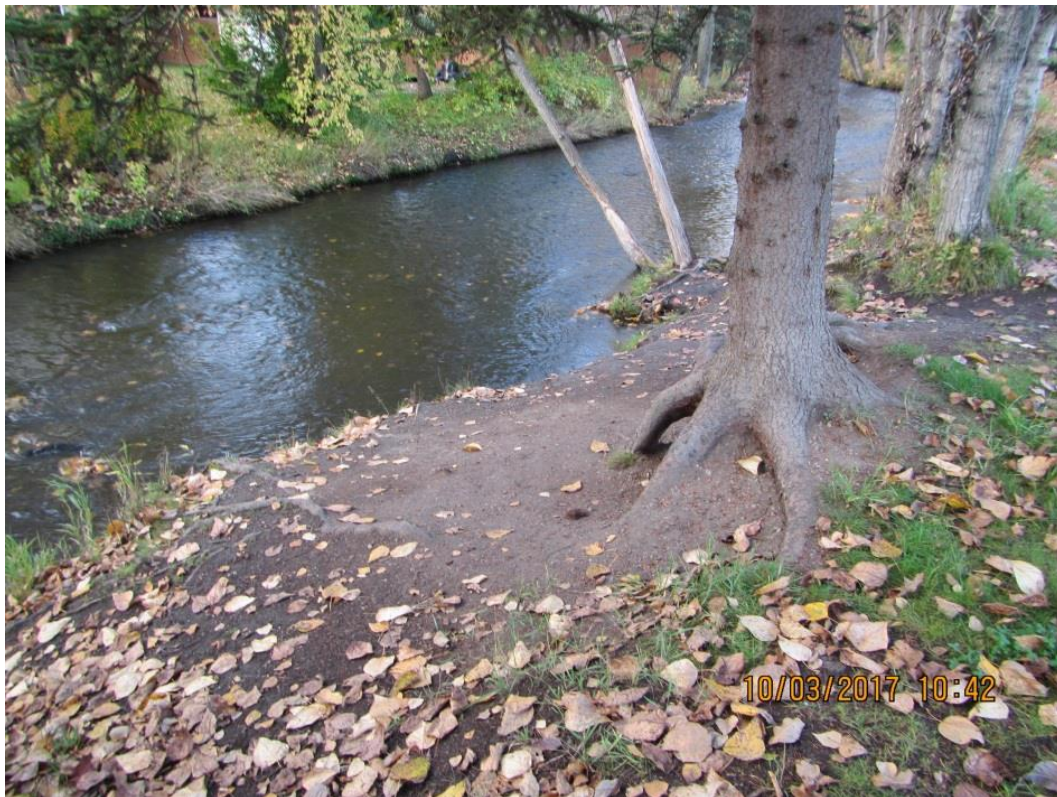
Fig. 9 West bank of Chester Creek in October 2017 showing persistent bank trampling (CW-4)

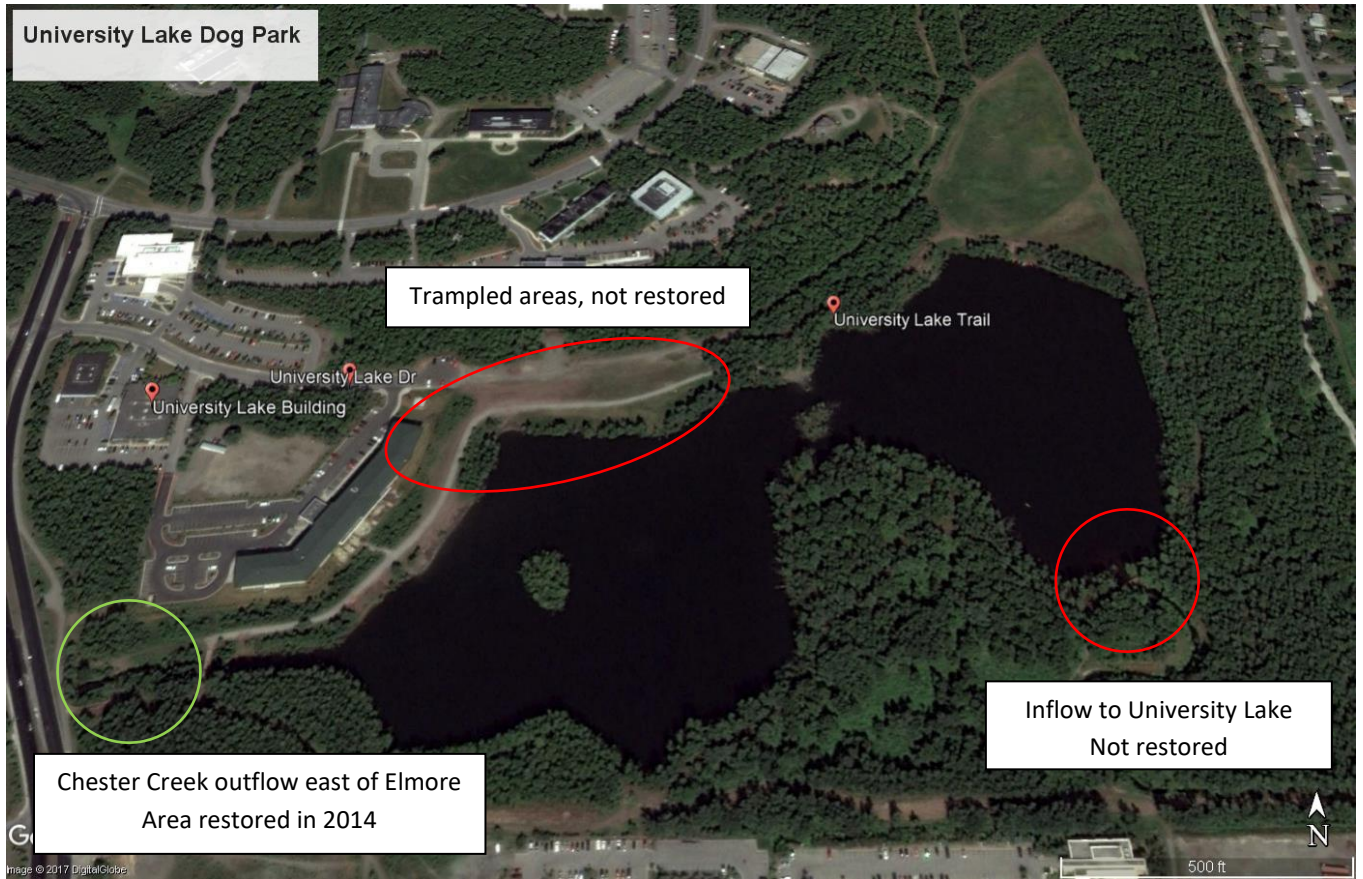
concern which need some intervention, however as of 2019 only one has been restored. This occurred in 2014, and AWC was a partner in the project³. This area is at the outflow of University Lake towards Elmore.

Fig. 12 Areas subject to erosion around University Lake and South Fork of Chester Creek from bank trampling (CSF-4)

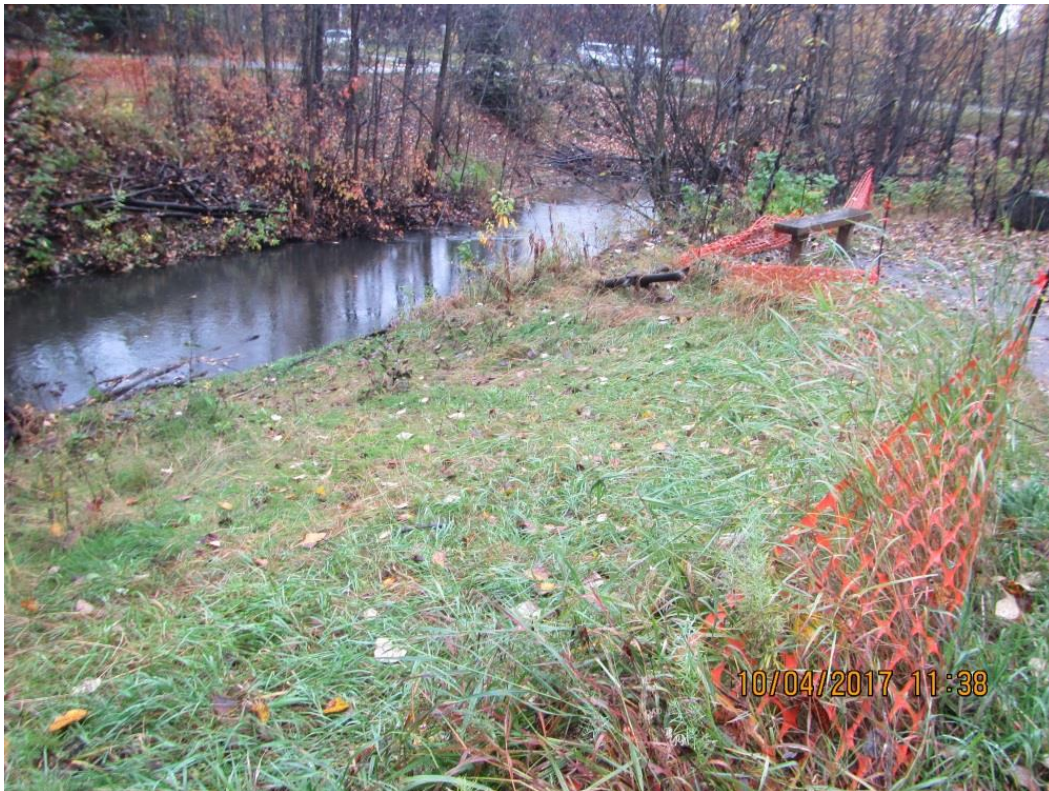
Fig. 14 North bank of S. Fork Chester Creek at University Lake outflow under Elmore in 2017 after 2014 bank restoration, CSF-4

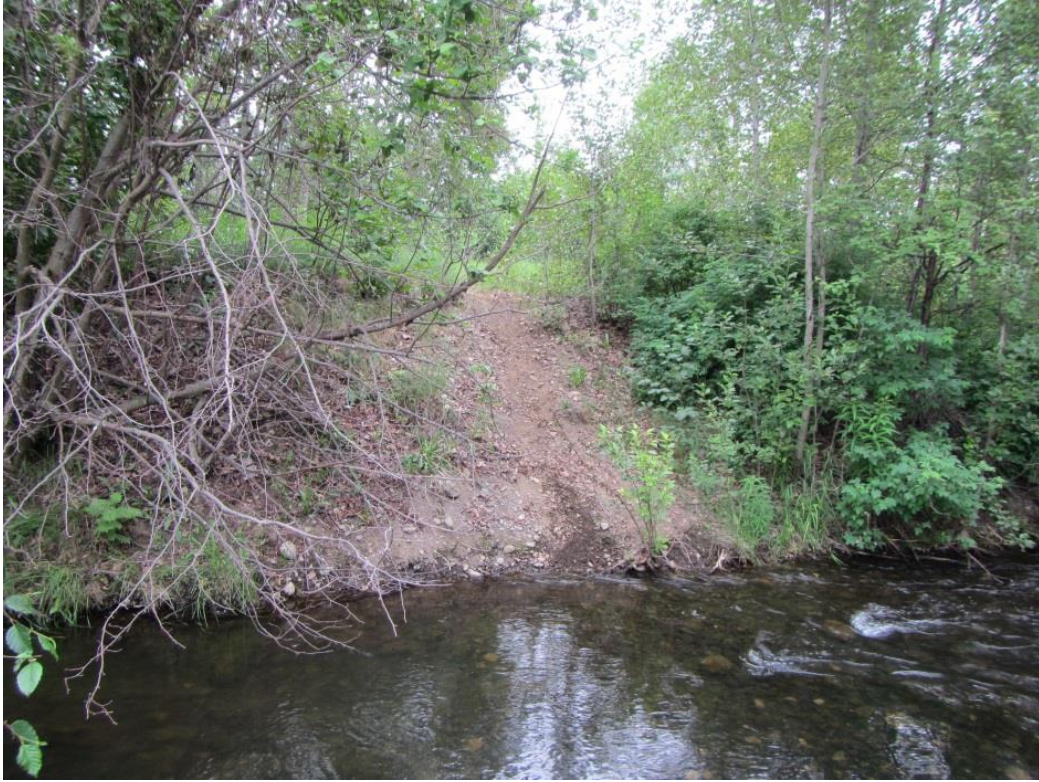
Fig. 15 South bank of S. Fork Chester Creek at University Lake at outflow under Elmore 2013, CSF-4

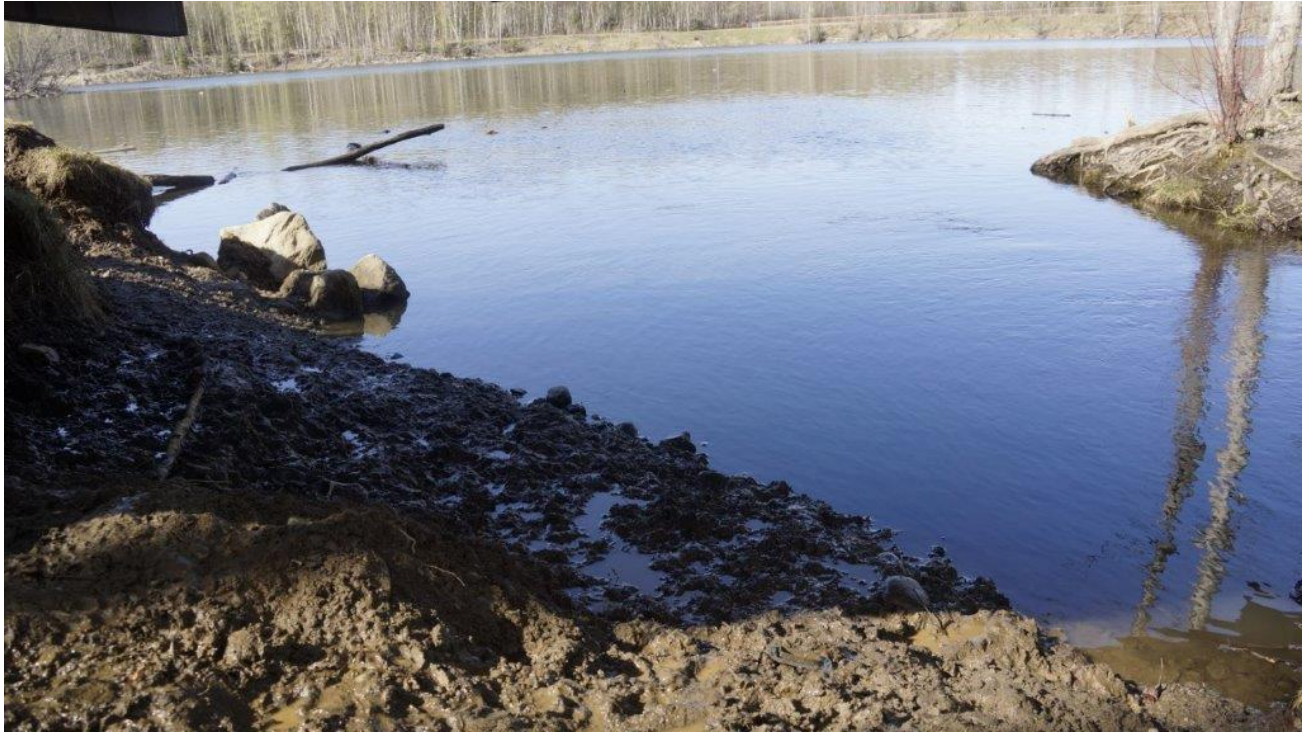
Fig. 17 Bank erosion in 2016 near foot bridge at S. Fork Chester Creek inflow to University Lake, CSF-4

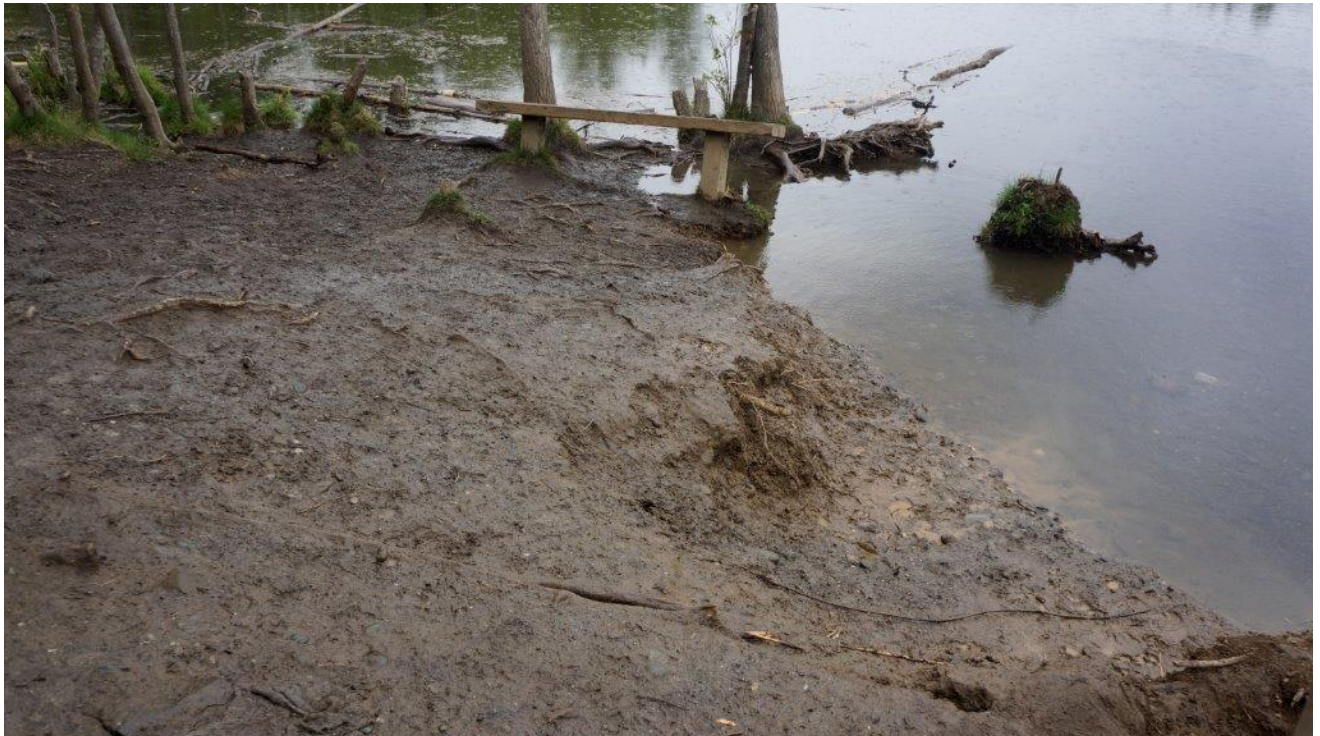
Fig. 18 Bank erosion in 2016 near foot bridge at S. Fork Chester Creek inflow to University Lake, CSF-4

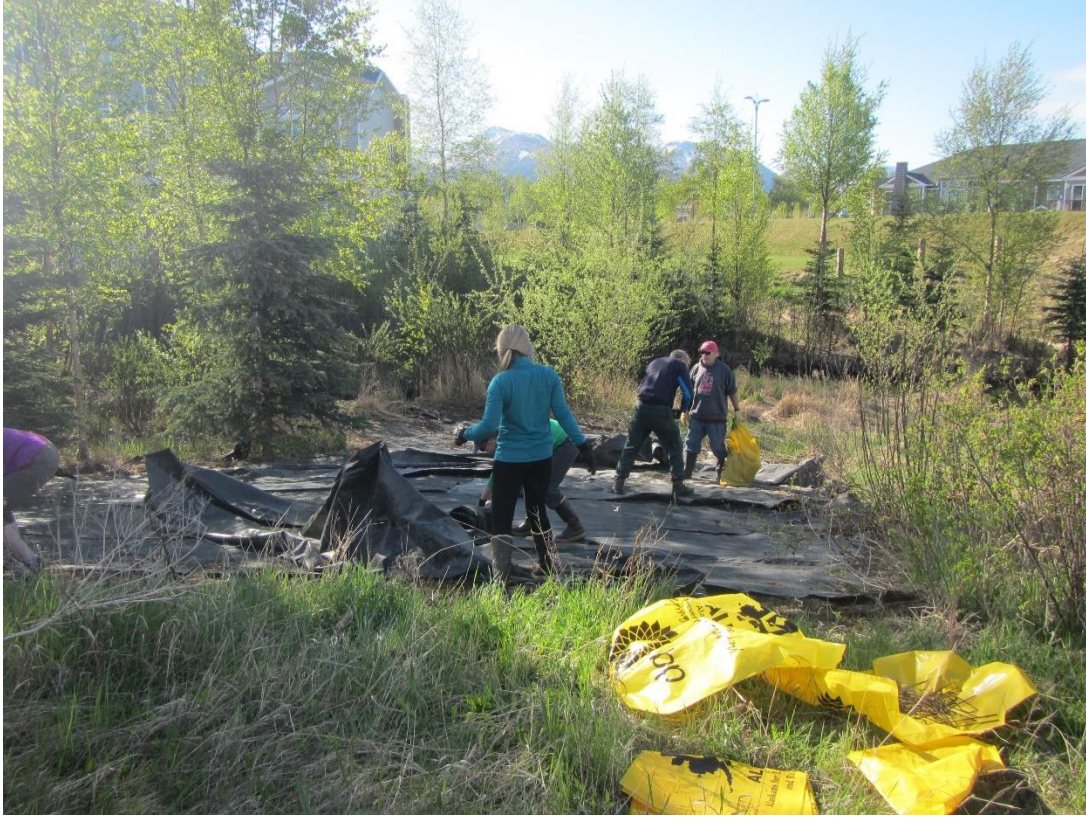
Fig. 21 Tarp removal by AWC in May 2016

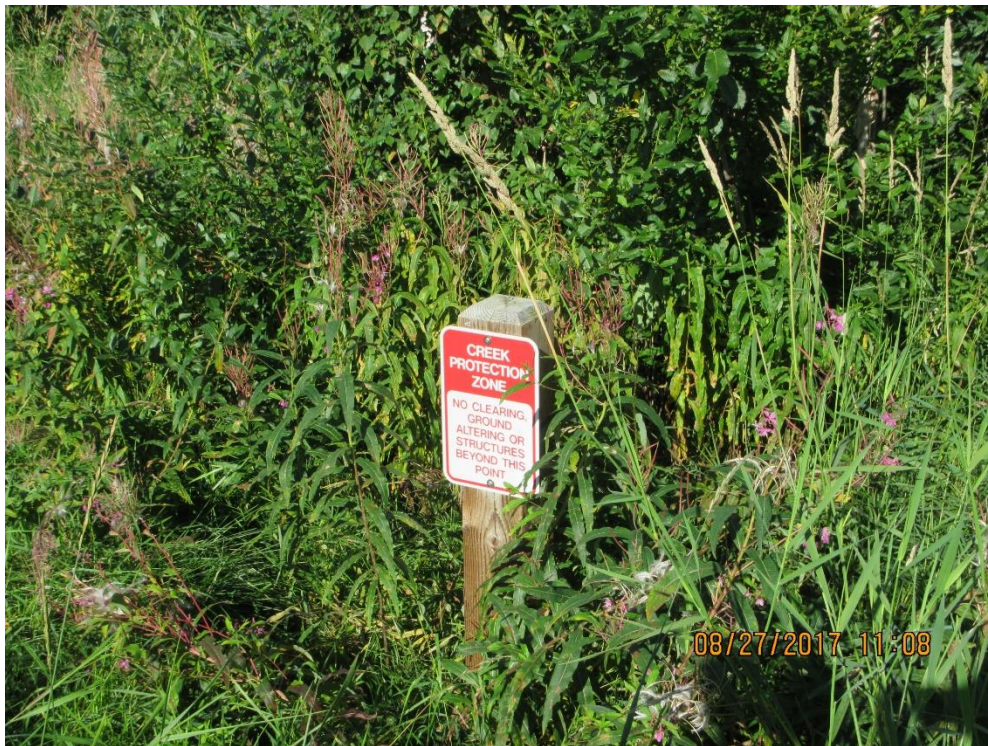
Fig. 22 Revegetated area in August 2017

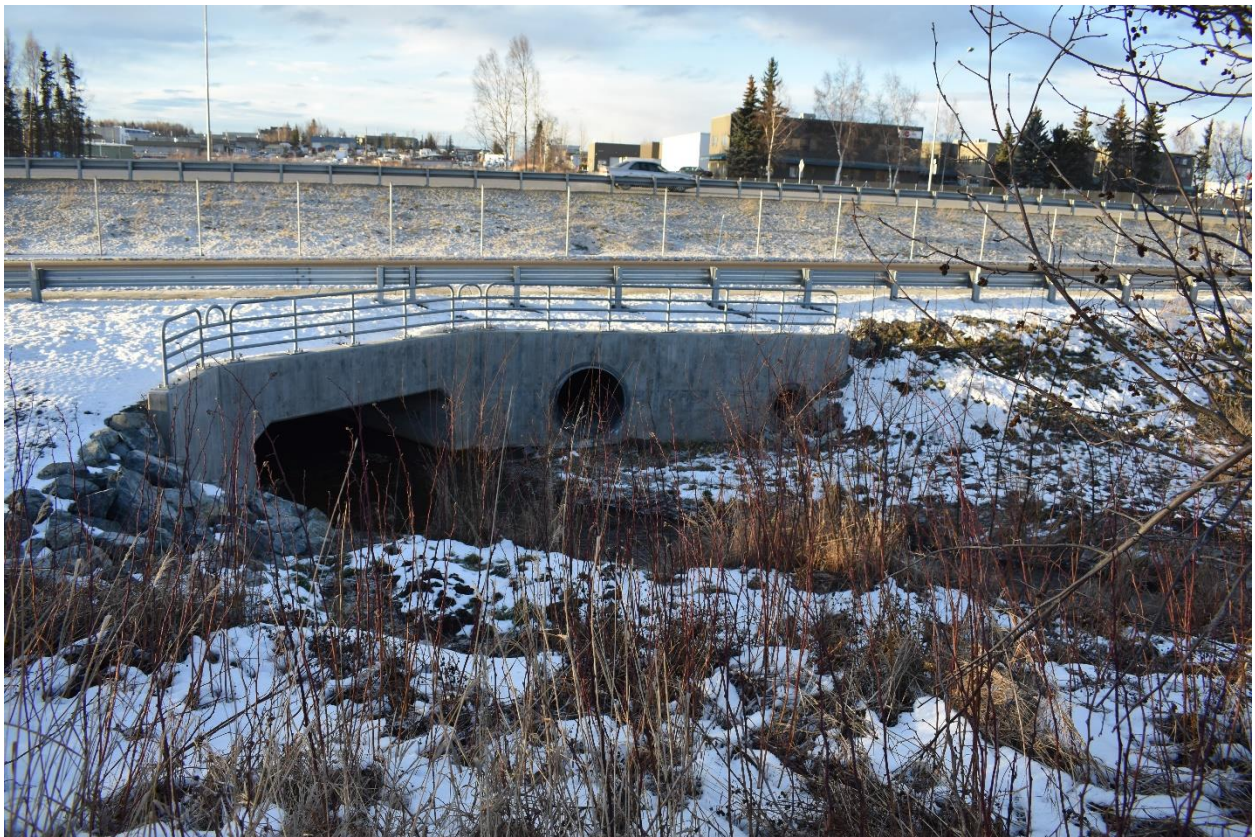
2.3 “Remove restrictions to flood flows”. This was a huge project, similar to the culvert replacement on Chester Creek at Muldoon, as it involved placing box culverts in the North and South Forks of Little Campbell Creek which run under the New Seward Hwy. The work was completed by 2017. Photos follow.

Fig. 35 N. Fork Little Campbell Creek inflow on the east under the New Seward at Brayton between 68th and 72nd looking west (2019)

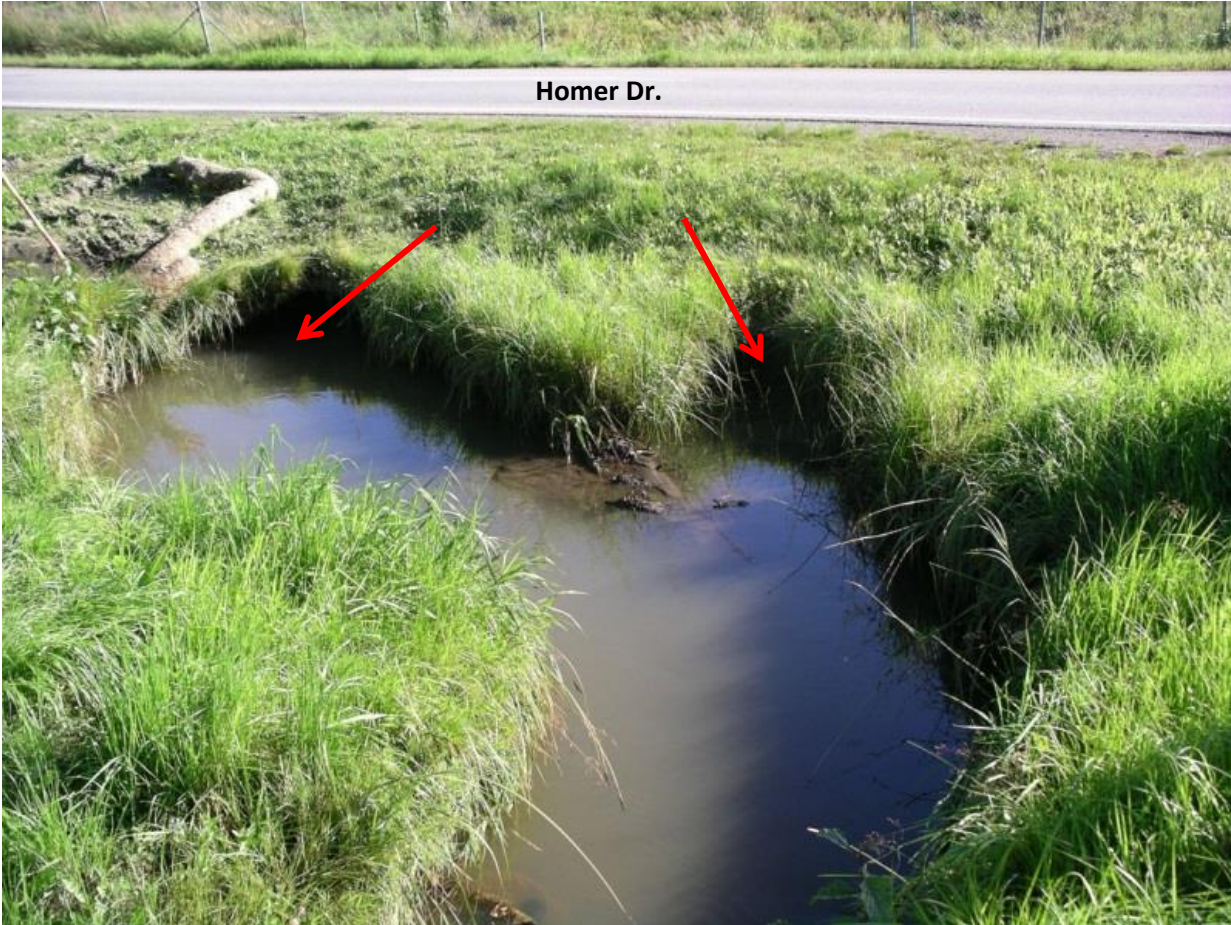
Fig. 37 N. Fork Little Campbell Creek outflow looking east under the New Seward at 70th and Homer (2010)

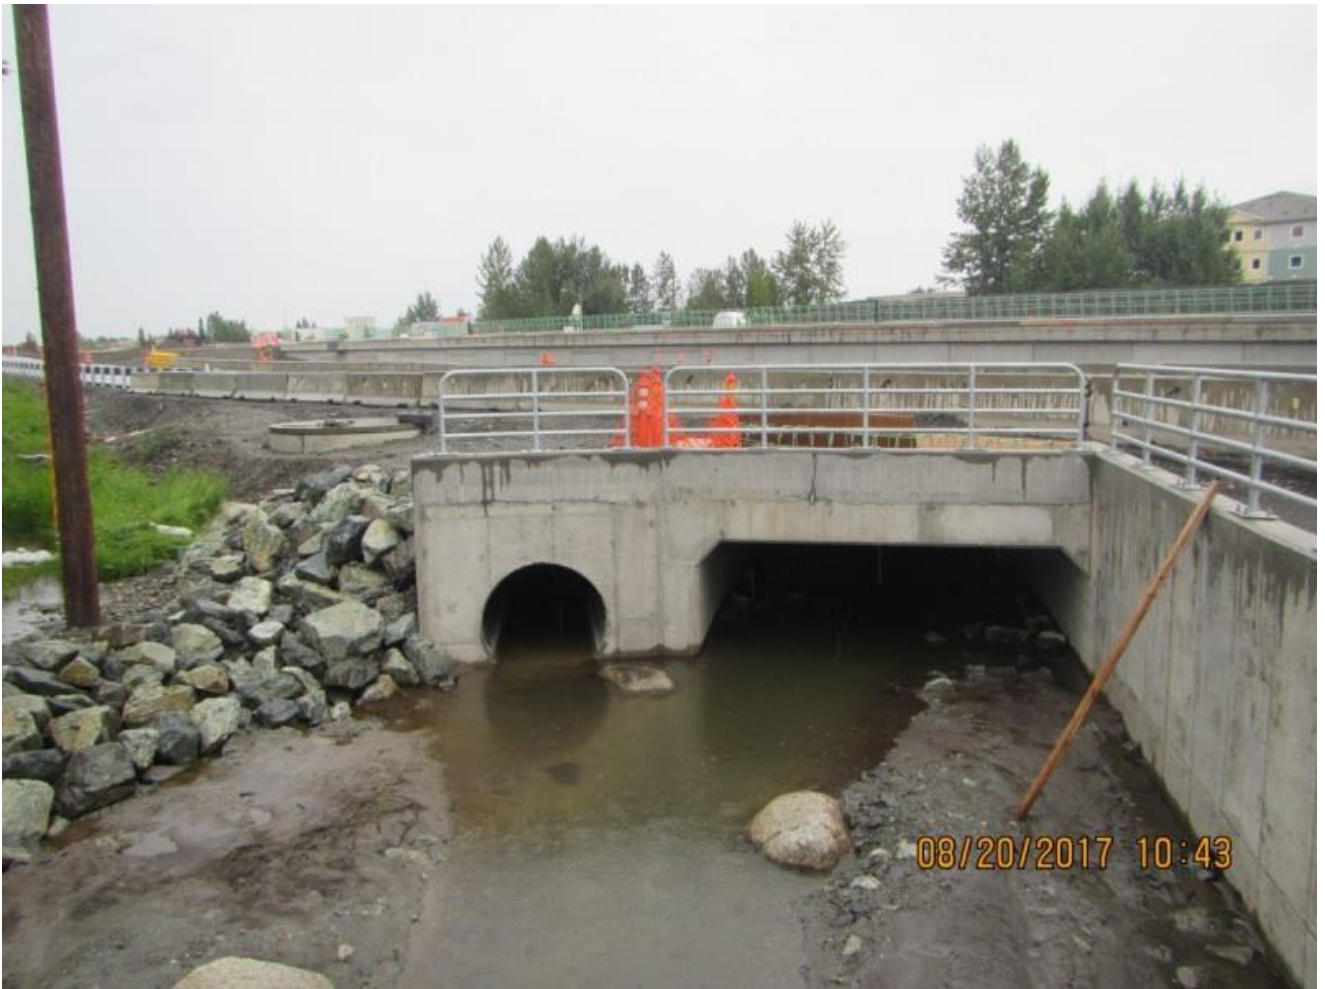
Fig. 38 New box culverts at N. Fork Little Campbell Creek outflow looking east under the New Seward at 70th and Homer (2017)

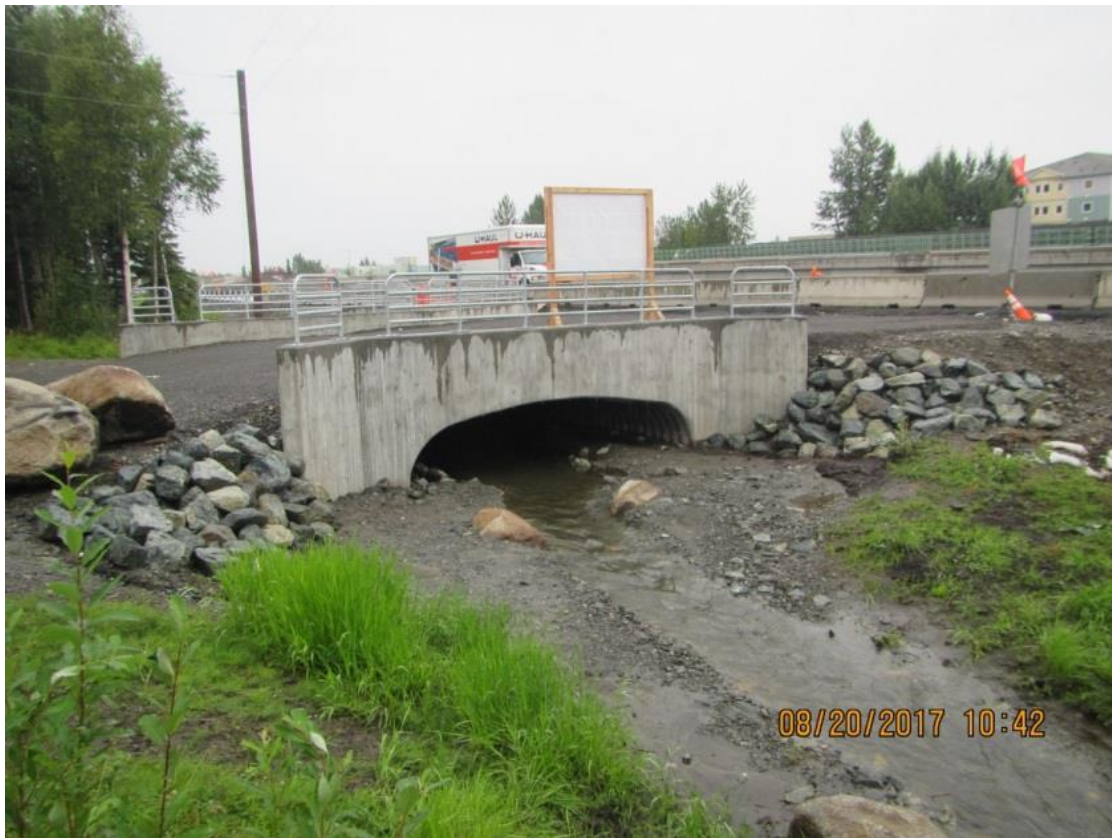
Fig. 40 View of the new driveway and large culvert at 70th and Homer over N. Fork Little Campbell Creek looking north (2017)

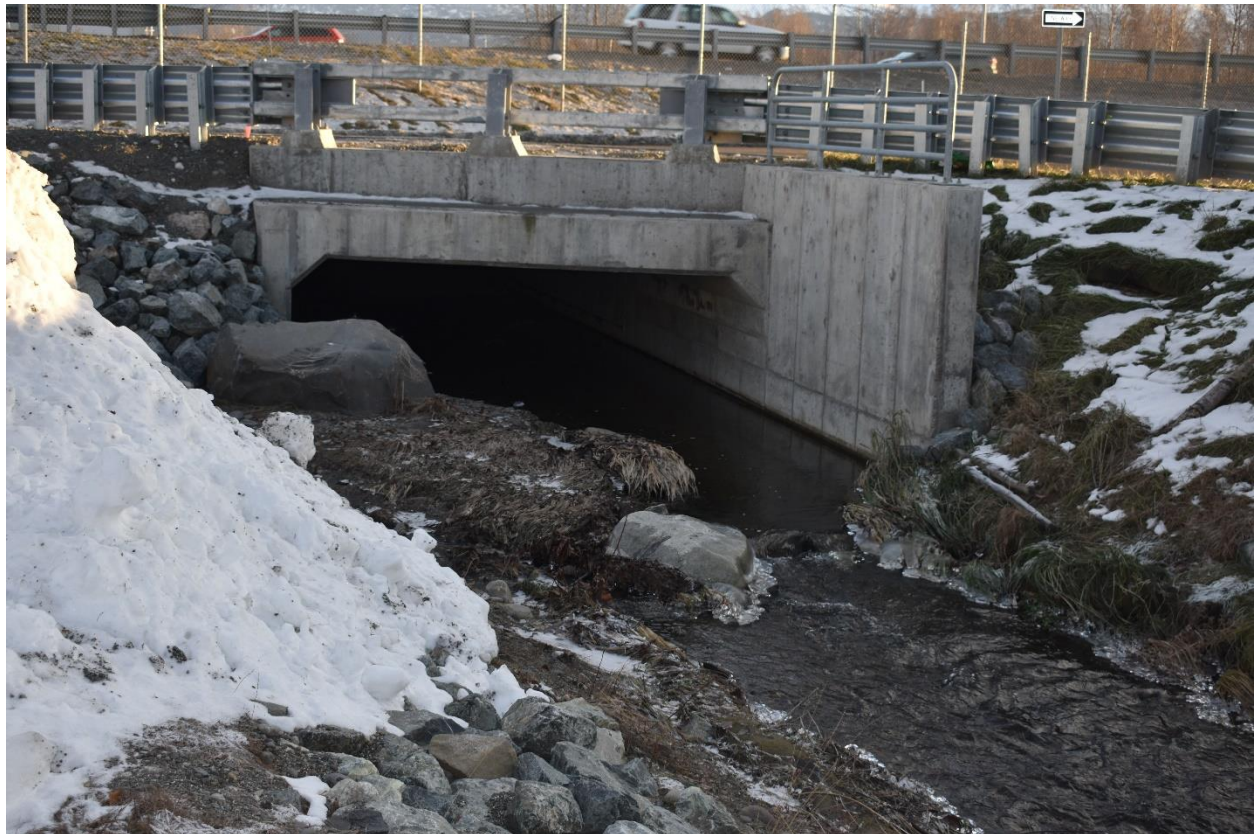
Fig. 42 S. Fork Little Campbell Creek, New Seward Highway culvert replacement at 80th and Homer looking east (2019)

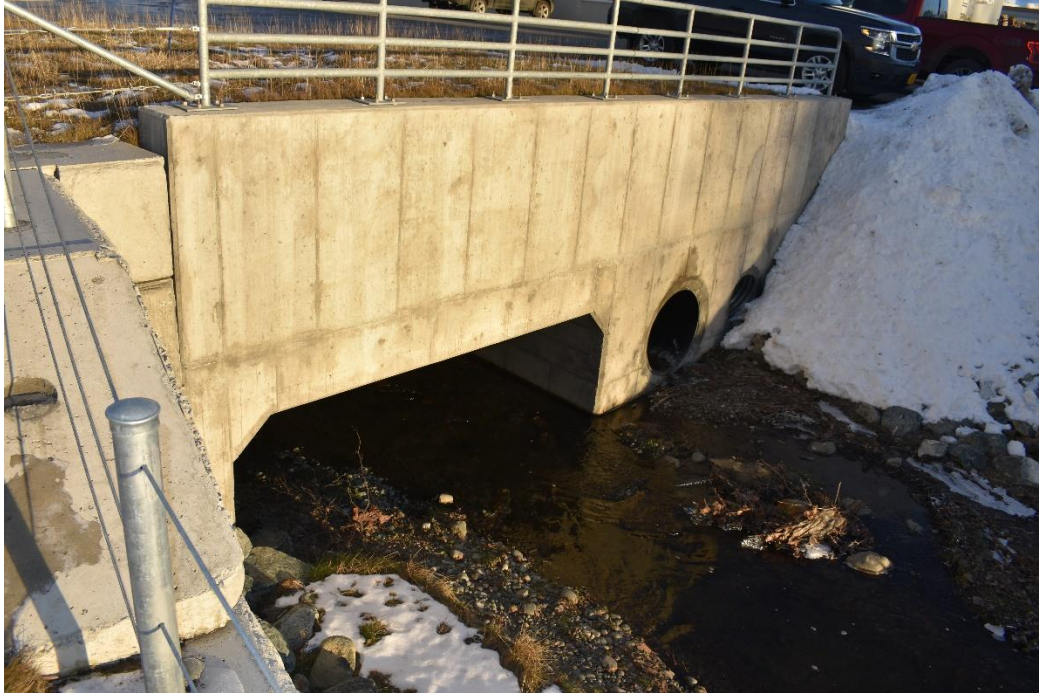
Fig. 43 S. Fork Little Campbell Creek, New Seward Highway culvert replacement at Brayton looking north as the culvert makes a turn to the west under the driveway over the creek (2019)

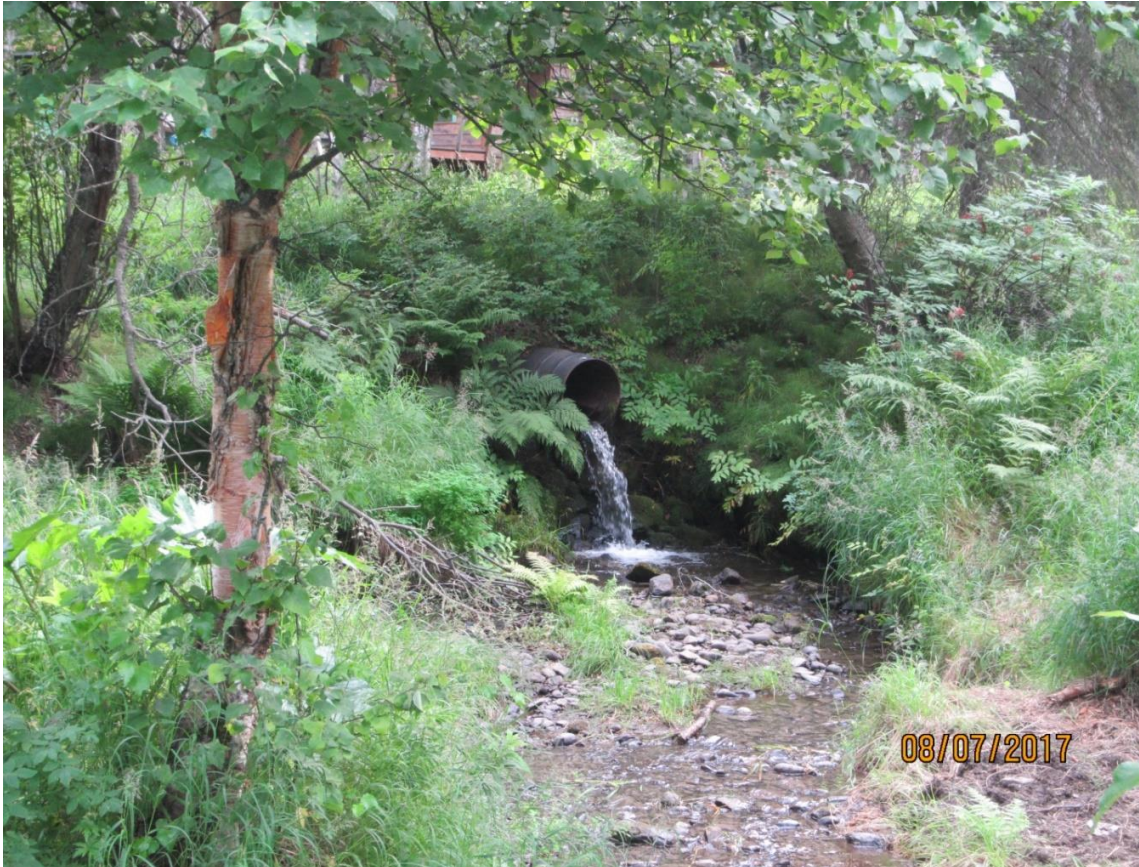
Fish passage through the Alaska Zoo was completed in 2015, but there is a perched culvert on S. Fork of Little Campbell Creek along Our Road just upstream of the zoo that does not allow fish passage at all.

Fig. 44 Perched culvert on S. Fork Little Campbell Creek just east of the Alaska Zoo’s boundary (2017)

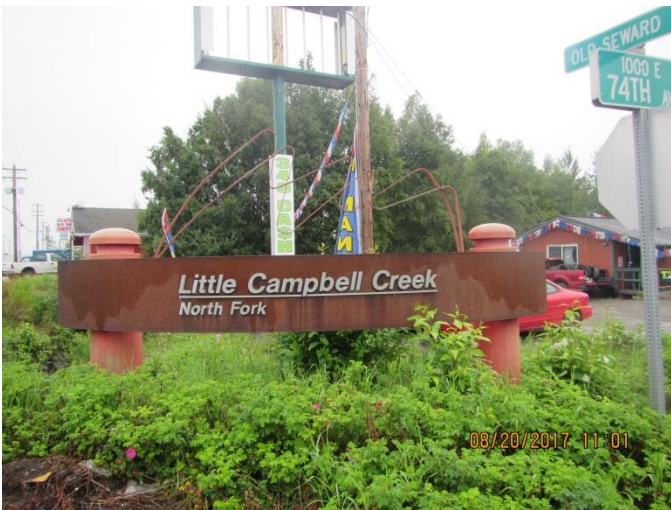
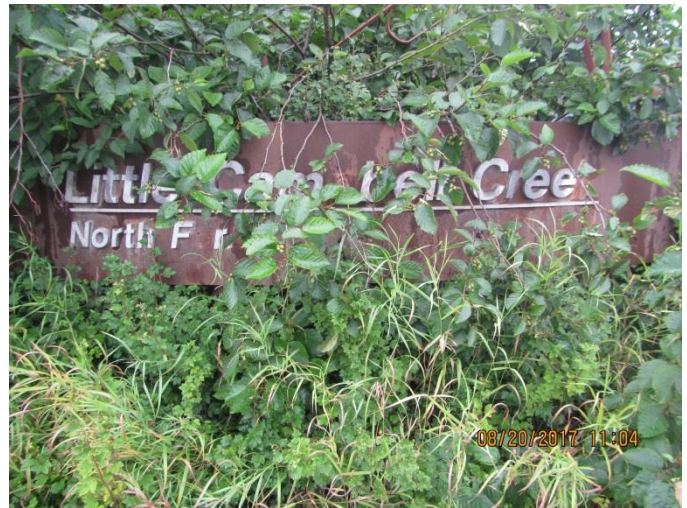
North Fork Little Campbell Creek east of Old Seward

1. North Fork Little Campbell Creek at Old Seward. Signs present but are in dire need of repair and cleaning.

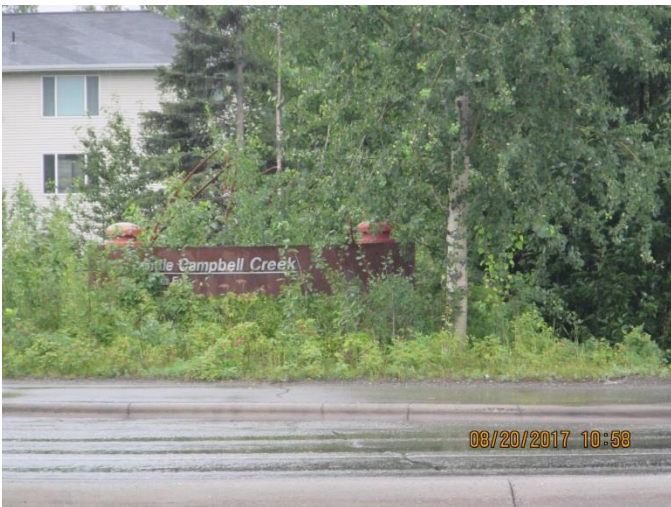
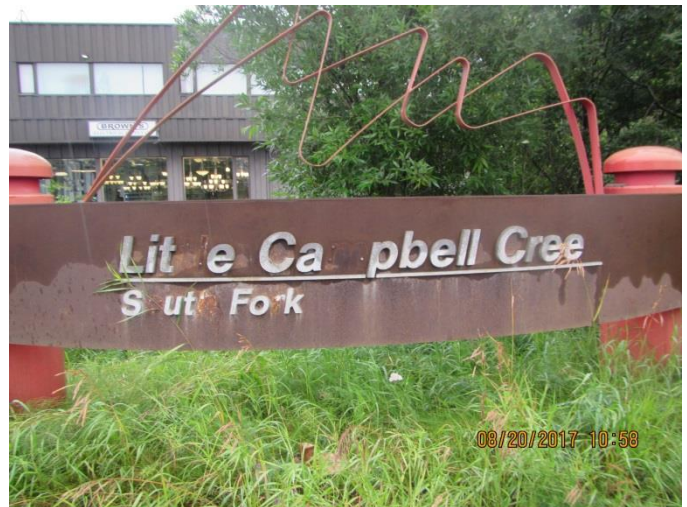
South Fork Little Campbell Creek east of Old Seward

2. South Fork Little Campbell Creek at Old Seward. Signs present but are in dire need of repair and cleaning.

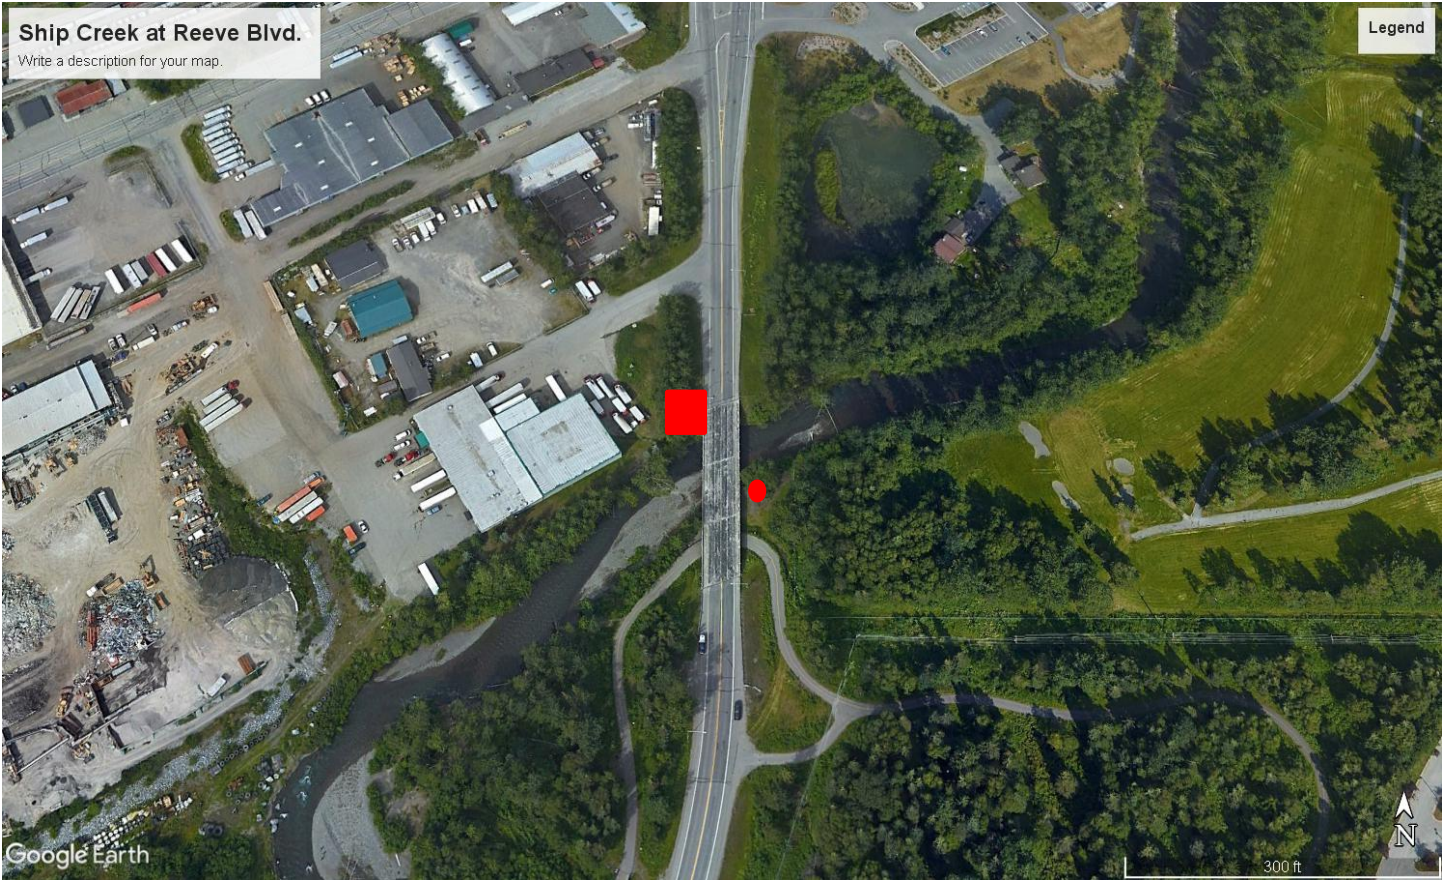
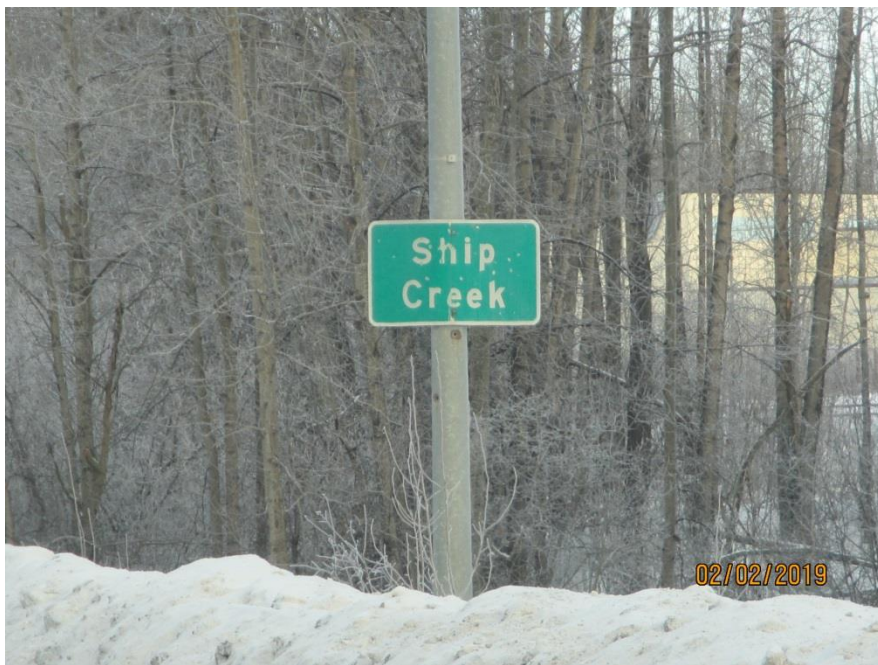
3. Ship Creek at Reeve Blvd. One sign heading north is there (below), one going south would be a good addition. The condition of the northbound sign is poor and could use replacing.
