2016 Dry Weather Screening Report

APDES Permit No. AKS052558

MUNICIPALITY OF ANCHORAGE
WATERSHED MANAGEMENT SERVICES

December 2016

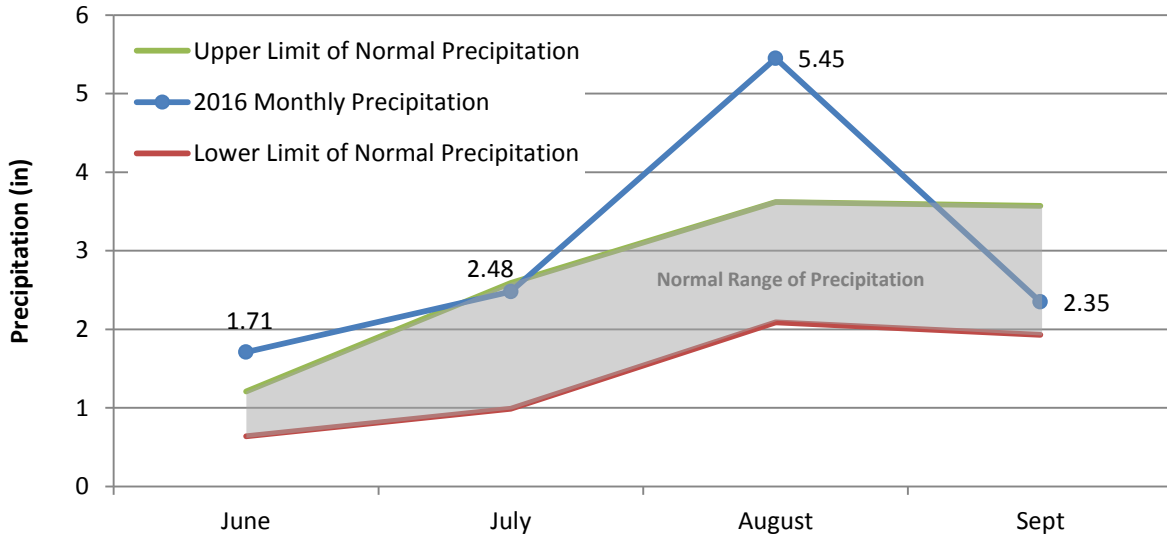
Figure 1. Monthly Precipitation in Anchorage, Summer 2016.

Notes: Precipitation data recorded at Ted Stevens International Airport.

Upper limit of normal precipitation = 75th percentile of monthly precipitation totals; lower limit of normal precipitation = 25th percentile of monthly precipitation totals.

Field sampling was conducted after at least 48 hours of dry weather following a storm event that created runoff in the MS4. The National Weather Service Forecast website (NWS 2016) was consulted to determine appropriate sample timing when necessary. The MS4 permit stipulates that dry weather screening should be conducted between June 1 and August 30 of each year. Conditions in the Anchorage area in summer 2016 were wetter than normal. The total precipitation that fell in June and August 2016 was higher than the range of normal precipitation,

and the total precipitation for July 2016 was within 0.1 inch of the upper limit of normal precipitation for July (2.59 inches; Figure 1).
